CASE STUDY

ChargePoint ensures consistent product quality within its EV charger assembly operation

ChargePoint adopts Instrumental's manufacturing AI and data platform to introduce greater standardization, scalability within its assembly process.

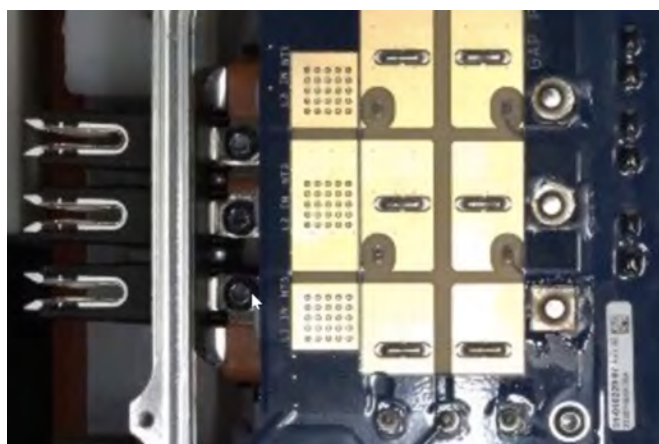
The electrical connection that makes ChargePoint EV modules work relies on bar clips that interface with the dispensers that attach to the charging stations. However, some bar clips looked angled. The initial assumption was that the bar clips were bent at the factory, meaning the operators likely misaligned the bar clips at the time of installation.

The ChargePoint team conducted a deeper analysis to confirm where and why the bar clips were damaged, however. They reviewed Instrumental AI images against the bar clip serial numbers and pinpointed three potential avenues that could cause the misalignment. It could either occur during the actual installation of the physical bar clips onto the enclosure, later on in the process when the black plastic front cover slides onto the module during the loading and unloading of the modules into testers or while in the field if mishandled by an operator.

Based on the Instrumental images, the team saw the first step – the actual installation of the bar clips onto the bar – looked consistent and accurate, and they were able to rule out failure at the time of installation. They learned the bar clip damage occurred in the field or when the black plastic front cover was installed, though they could not definitively pinpoint only one cause. “Since we knew the failure could be caused by the plastic cover insert, we kicked off new fixturing that improved the manufacturing process, ensuring the bar clips wouldn’t get stuck, which helped to reduce the number of failures in the field,” said Mansour.

First potential failure point: bar clip install

Without Instrumental’s images, the ChargePoint team would have had to look more deeply at earlier stages (stations one through six) within the assembly process to confirm whether there was an issue with the installation of the parts. This would have been an incredible time- and resource-intensive process—instead, they only had to analyze station seven.

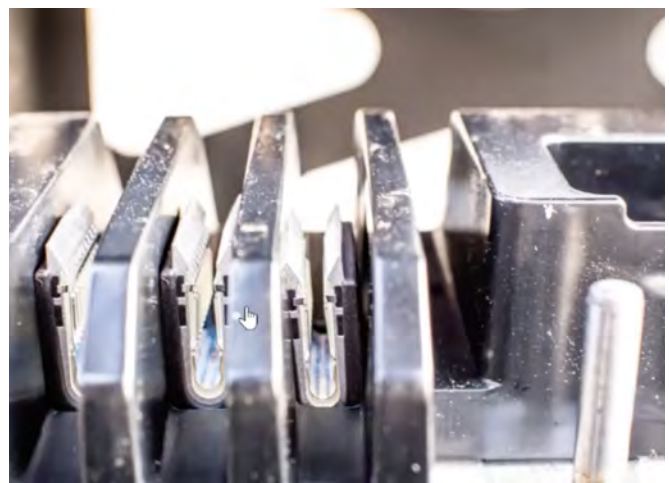
*Second potential failure point:
black plastic front covers installed onto module*

This specific challenge, had we not been able to narrow down the cause, would have spiked many conversations with multiple stakeholders over two weeks—the bar clips are that important,” said Mansour. **“Instrumental AI images gave us hard proof of where the misalignment was likely occurring and allowed the team to implement a solution to help avoid further damage quickly.”**

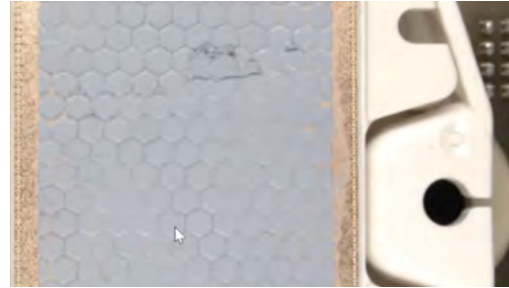
ChargePoint was experiencing a string of issues on one line where they saw failures in the testers because of some mechanical damage to the corner of one of their custom modules. They needed to assess whether the damage occurred during the assembly process, if it was a supplier issue, or if operators were somehow responsible for the defect.

The team conducted a root cause analysis, closely examining images of the modules to see whether they could pinpoint where, when, and why the damage occurred. They referenced their catalog of Instrumental images against the serial numbers of the damaged modules and found a glare on the corner, with the light hitting it at an angle, indicating that the corner was bent. From there, the team discovered

the root cause of the issue, identifying that metal wires protruded when operators scraped the silkscreens, inflicting damage on the corner of the modules.

Anomalous module with glare on the corner - image captured by Instrumental

The ChargePoint team then implemented a new workflow based on these observations, putting a new fixture on the line to avoid future damage. They now use the Instrumental system to passively track the progress on this station to ensure they're not sourcing the same defect after their corrective actions.
